REPORT NO. NADC-76332-30

INVESTIGATION OF A LIQUID OXYGEN SAMPLER CYLINDER EXPLOSION

J. Danovich and E. R. Wright
Air Vehicle Technology Department ✓
NAVAL AIR DEVELOPMENT CENTER
Warminster, Pennsylvania 18974

10 DECEMBER 1976

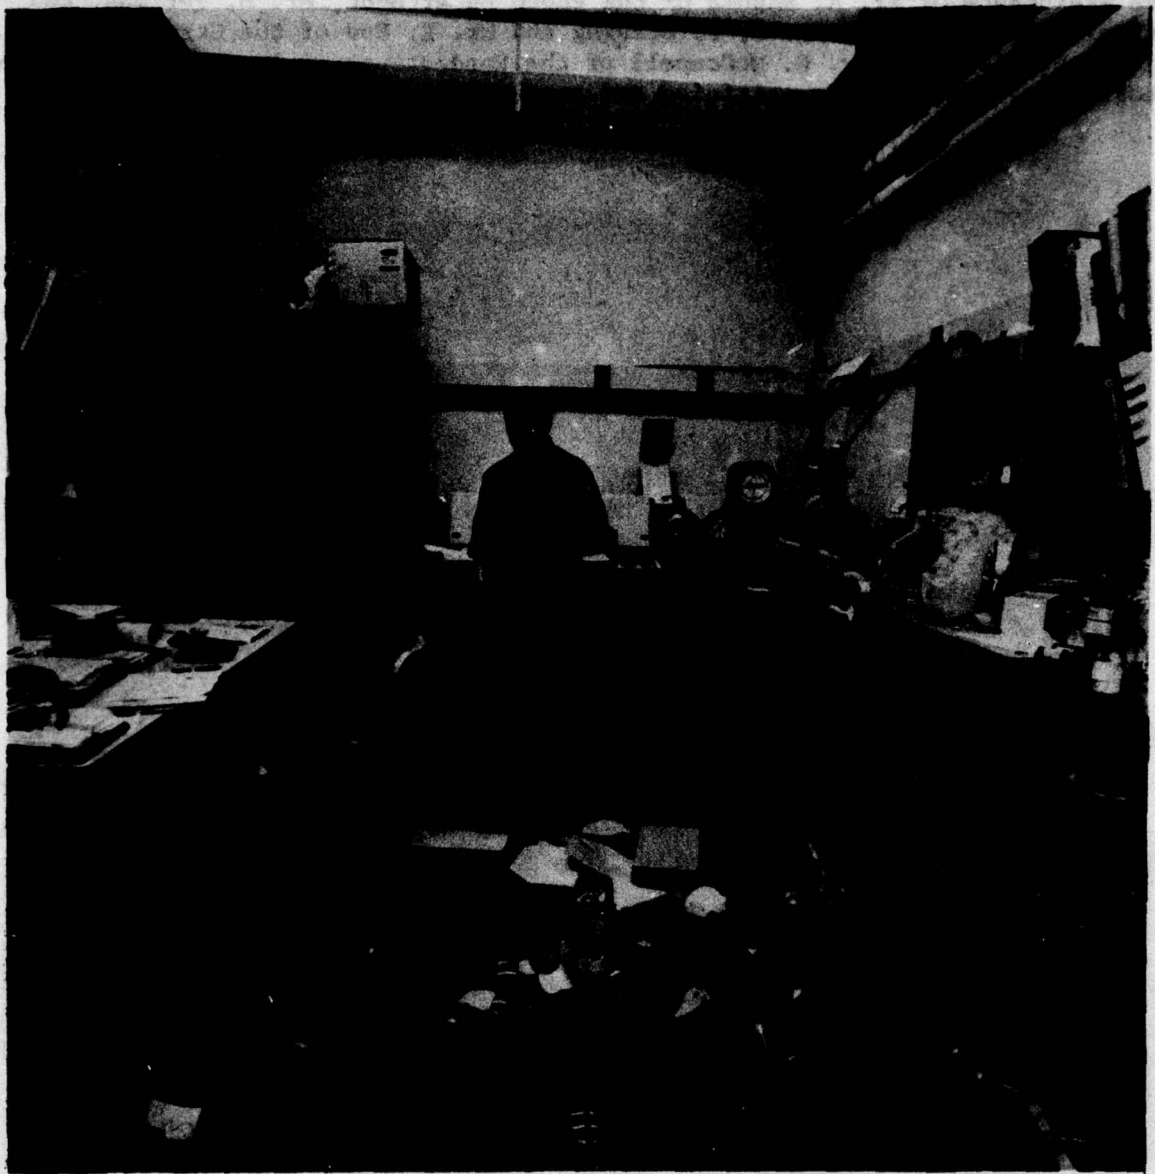
It was noted by laboratory personnel at the time of delivery that one sampler cylinder was completely covered with frost whereas the other sampler was frost-free. While test preparations were underway a steel retaining band on the frosted cylinder cracked and fell to the floor. Approximately five minutes later the frost-covered cylinder exploded. Figures 1, 2, 3 and 4 show some of the extensive physical damage caused by the explosion. A laboratory technician who was standing in the location shown in Figure 1 sustained minor cuts and a temporary loss of hearing. Three major sections of the exploded cylinder came to rest in the locations shown in Figures 2 and 3. Figure 4 shows a typical G-276 LOX sampler cylinder in a stand near an area of the damaged wall in the hallway and some of the shattered steel bands. Figure 5 shows the various parts of the exploded cylinder. It appears that the valve, nipple and sampler filler tube, upon separation from the exploding cylinder, were propelled upward to the ceiling, causing some damage and finally landing on the floor about four feet apart. The wire bands were scattered throughout the area as shown in Figures 1, 2, 3 and 4.

Figure 1. Room Where the Explosion Occurred

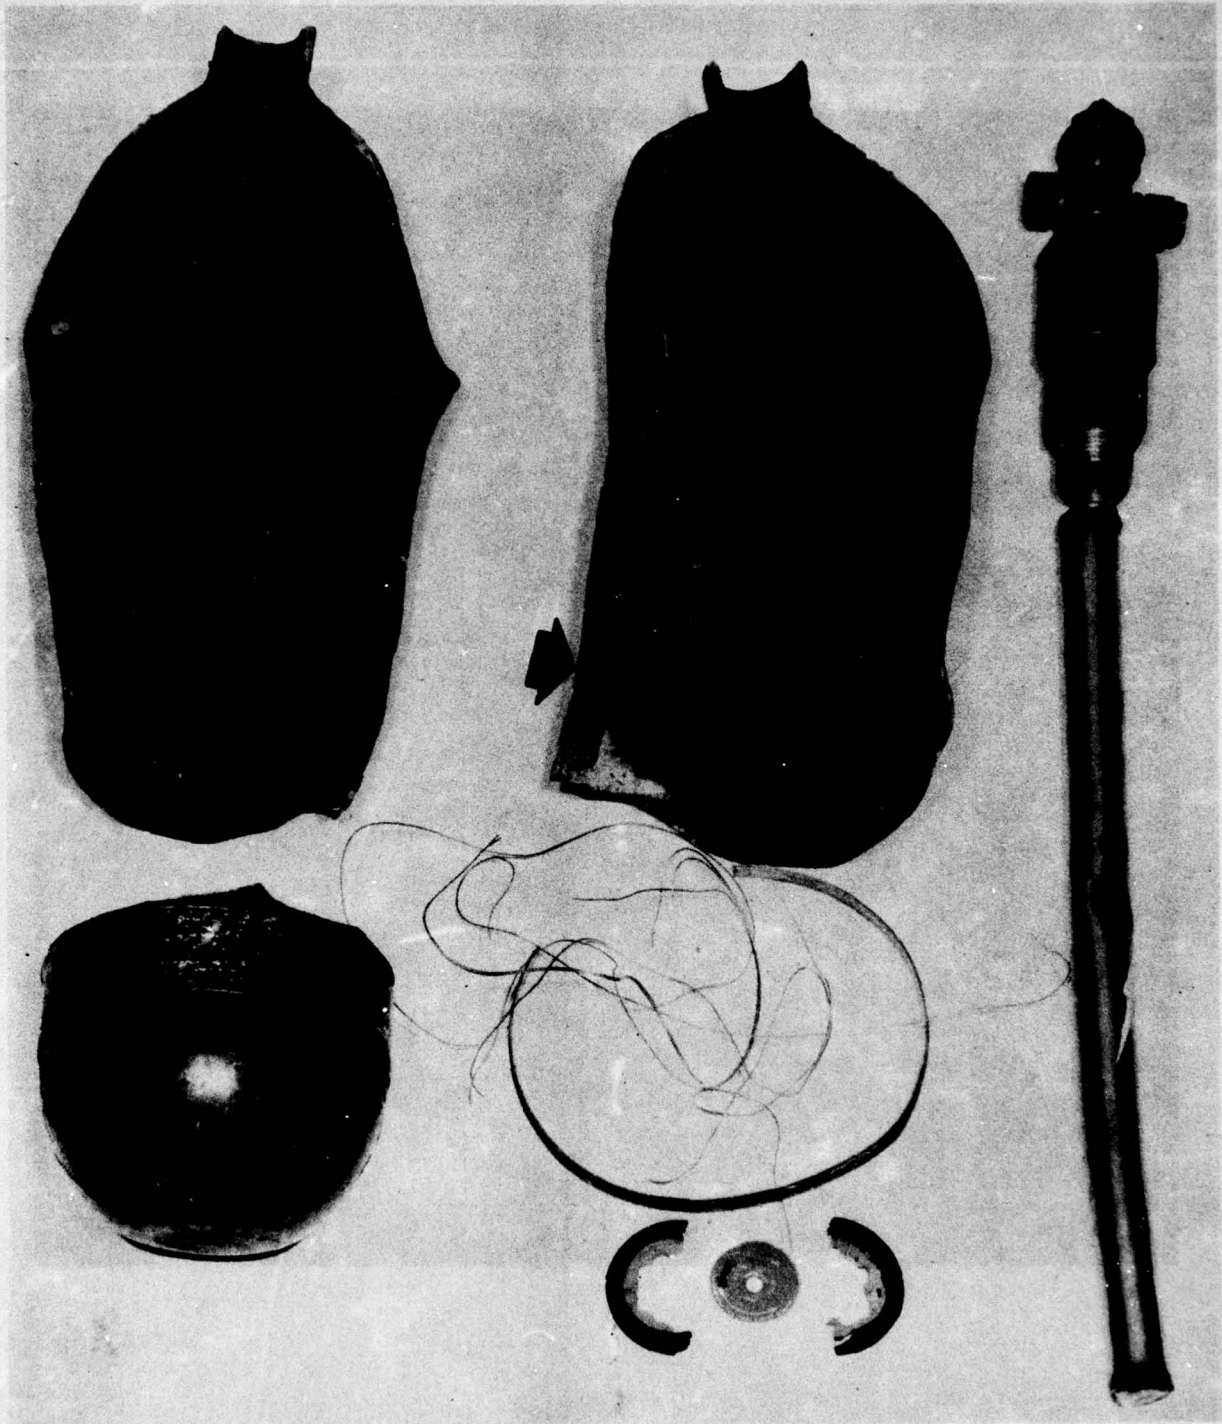
Figure 5. Parts of the Exploded Cylinder

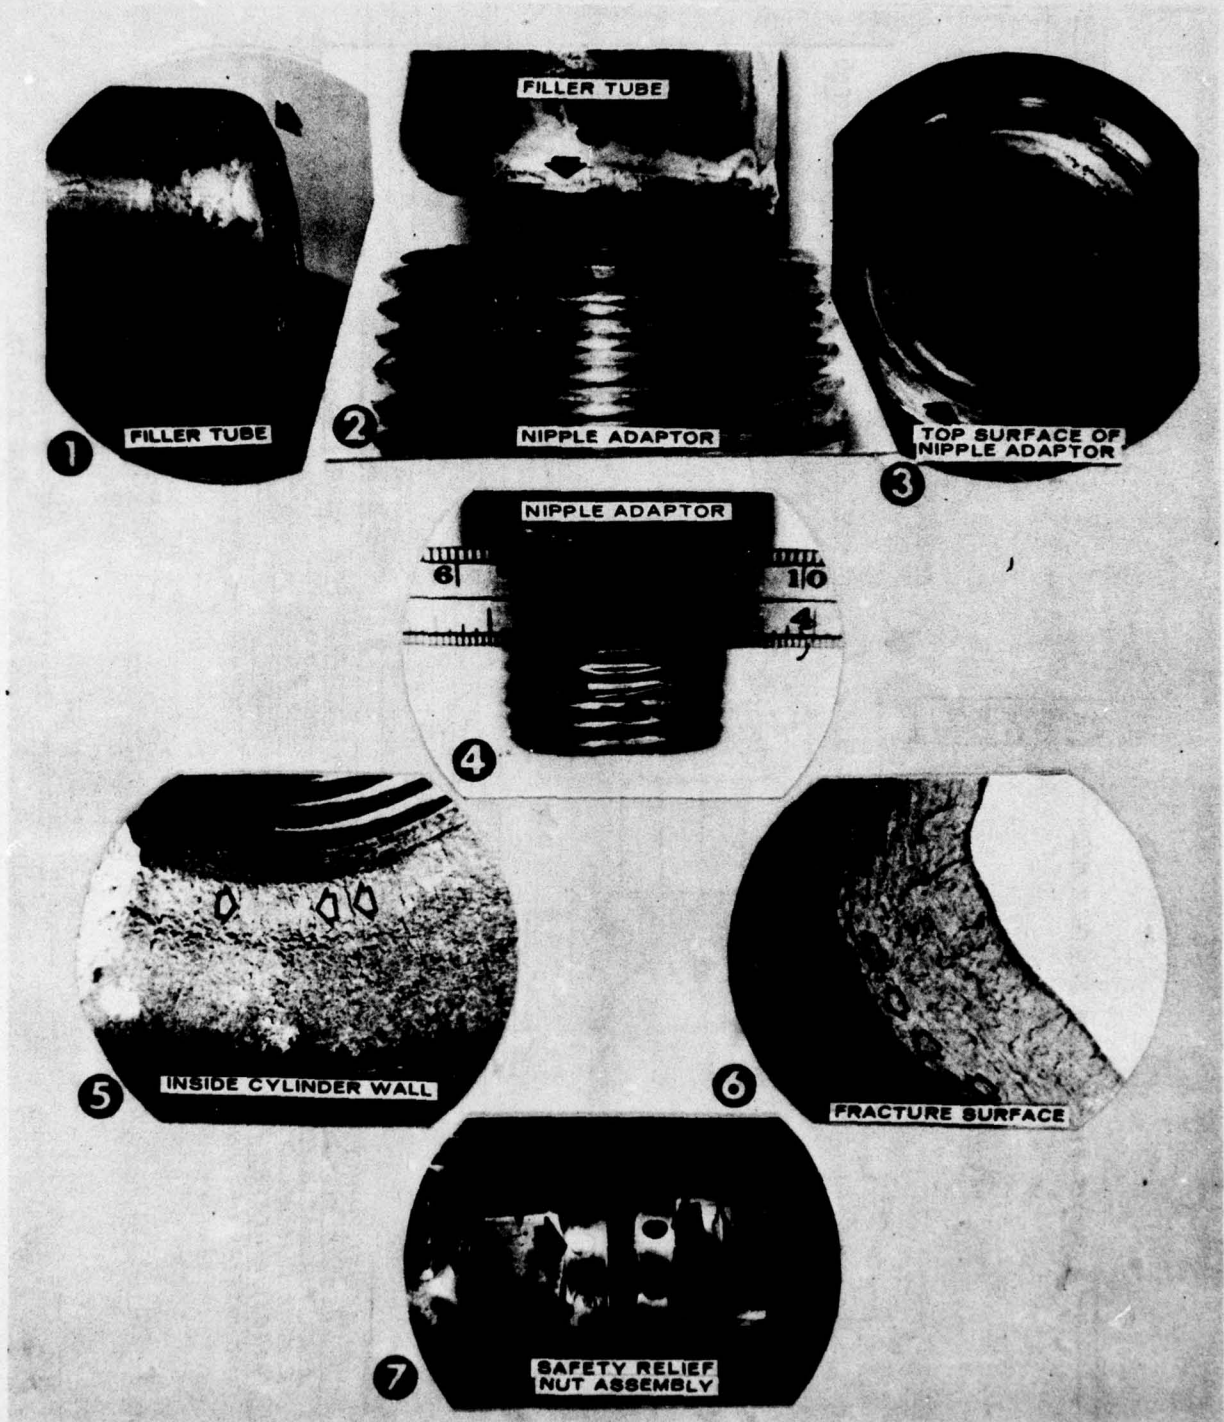
Detailed photos of the tube, nipple and exploded cylinder are shown in Figure 6. Close examination of photos 1, 2 and 3 (Figure 6) show that many areas along the circumference of the tube and nipple were void of silver solder (see arrows). Specifications of the nipple assembly from the Naval Air Station, Alameda, California, O&R Department Drawing 212258 of 5 December 1958 (Figure 7) show that the stainless steel tube should have been recessed into a 0.26" (0.66 cm) counterbore. The SS tube from the exploded sampler was found to be counterbored less than 0.062" (0.158 cm), practically forming a butt weld with very little filler metal. It is believed that a crack between the tube and nipple existed prior to the last sample charge. This separation permitted an excess volume of LOX to overflow into the cylinder during the filling of the sampler tube. The discoloration of the inside of the cylinder as shown in Figure 5 (arrow) shows that liquid was present in the lower portion of the cylinder. Photo 4 (Figure 6) shows some damage to the threads of the nipple adaptor. The slight damage to the nipple threads and also to the cylinder threads (not shown) indicates the separation of the adaptor assembly and cylinder occurred simultaneously with the rupture of the cylinder walls. Photos 5 and 6 show cracks (open arrows) in the interior surface below the threads in the neck of the

cylinder. These cracks are visible without the aid of any magnification. The maximum depth of the cracks found three-fourths of an inch from the ANPT thread was 0.015" (0.038 cm). The minimum wall thickness at this point was 0.343" (0.871 cm), or a crack depth of 4.5% of the wall thickness. Cracking was detected to a distance of 1-3/4" (4.445 cm) from the ANPT thread. At this point the crack penetrated to a maximum depth of 0.0075" (0.019 cm) where the wall thickness was 0.156" (0.396 cm), or a crack depth of 5% of the wall thickness. Photo 7 shows the pressure relief assembly nuts which are extensively used on the Navy G-276 sampler exit valves. These nuts have access ports which can be filled with fusible metal alloy which will melt when excess temperatures occur, allowing the safety rupture disc to release the excess pressure. The nut on the left has a fusible metal alloy behind the safety burst disc. The pressure relief nut on the right shows no fusible metal alloy in the access ports. Since all Navy G-276 LOX samplers are designed for low temperature use, the presence of the fusible metal alloy would prevent the escape of excess LOX pressure. Therefore, all Navy G-276 sampler valves should have a safety relief nut without the fusible alloy. The safety relief nut on the valve of the exploded cylinder still had the fusible metal alloy behind the safety disc.

Based on the evidence available, it is believed that the explosion occurred because a separation between the nipple and the stainless steel sampler tube allowed leakage of LOX beyond the filler tube. The excess volume of LOX which accumulated in the bottom of the cylinder produced a gas pressure buildup which exceeded the bursting strength of the cylinder. The use of an unbacked safety disc on the vent valve assembly would have permitted the pressurized gas to escape.

Figure 6. Detailed Photos of the Exploded G-276 Sampler

Appendix A gives a detailed inspection procedure for G-276 Liquid Oxygen Sampler Cylinders. It is recommended that this inspection procedure be followed.
